Queensland's timber and iron lighthouses: 19th century colonial innovation

Peter Marquis-Kyle, conservation architect, Brisbane

SUMMARY: The geography, resources and economic circumstances of the colony of Queensland fostered the local design and construction of two related types of composite timber-framed, iron-clad lighthouse towers in Queensland from the 1870s – an early type clad with riveted wrought iron plating, and a later type clad with corrugated galvanised iron. This paper gives a short historical account of their design and construction, outlines the range of towers and how they have been changed. The paper concludes with an assessment of the success and influence of the type, and a table of major 19th century lighthouses.

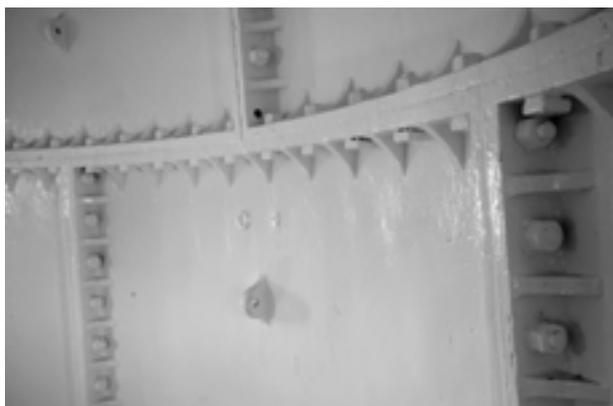
Figure 2. The cast iron plates of the Bustard Head lighthouse tower

cast iron segments made to be bolted together on their sites. The two towers were manufactured by different foundries in England, though their designs were similar. The Bustard Head tower was cast by Hennet & Spink of Bridgwater in Somerset, and the Sandy Cape tower by Kitson & Co of Leeds in West Yorkshire. Both were equipped with lantern houses and optical apparatus manufactured by Chance Brothers & Co of Smethwick near Birmingham, the major English lighthouse equipment maker. The Bustard Head lighthouse was first lit in 1868, and Sandy Cape in 1870. These fully-imported cast iron lighthouses were effective, though costly.⁴

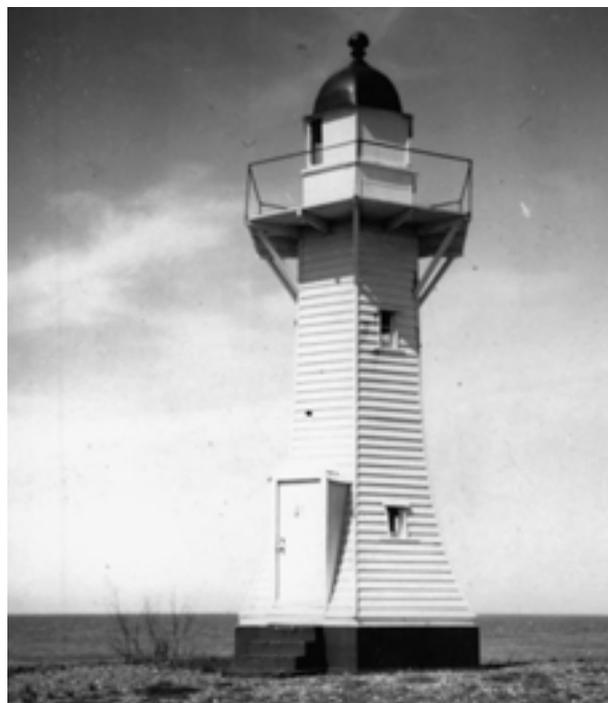
Figure 3. Burnett Heads lighthouse (photo: Bundaberg Regional Council collection)

These timber towers – with their hardwood frames, truncated pyramidal forms, and horizontal weatherboard sheathing – were similar to New Zealand lighthouses designed by John Blackett through the 1870s and 1880s.⁷ Blackett acknowledged North American

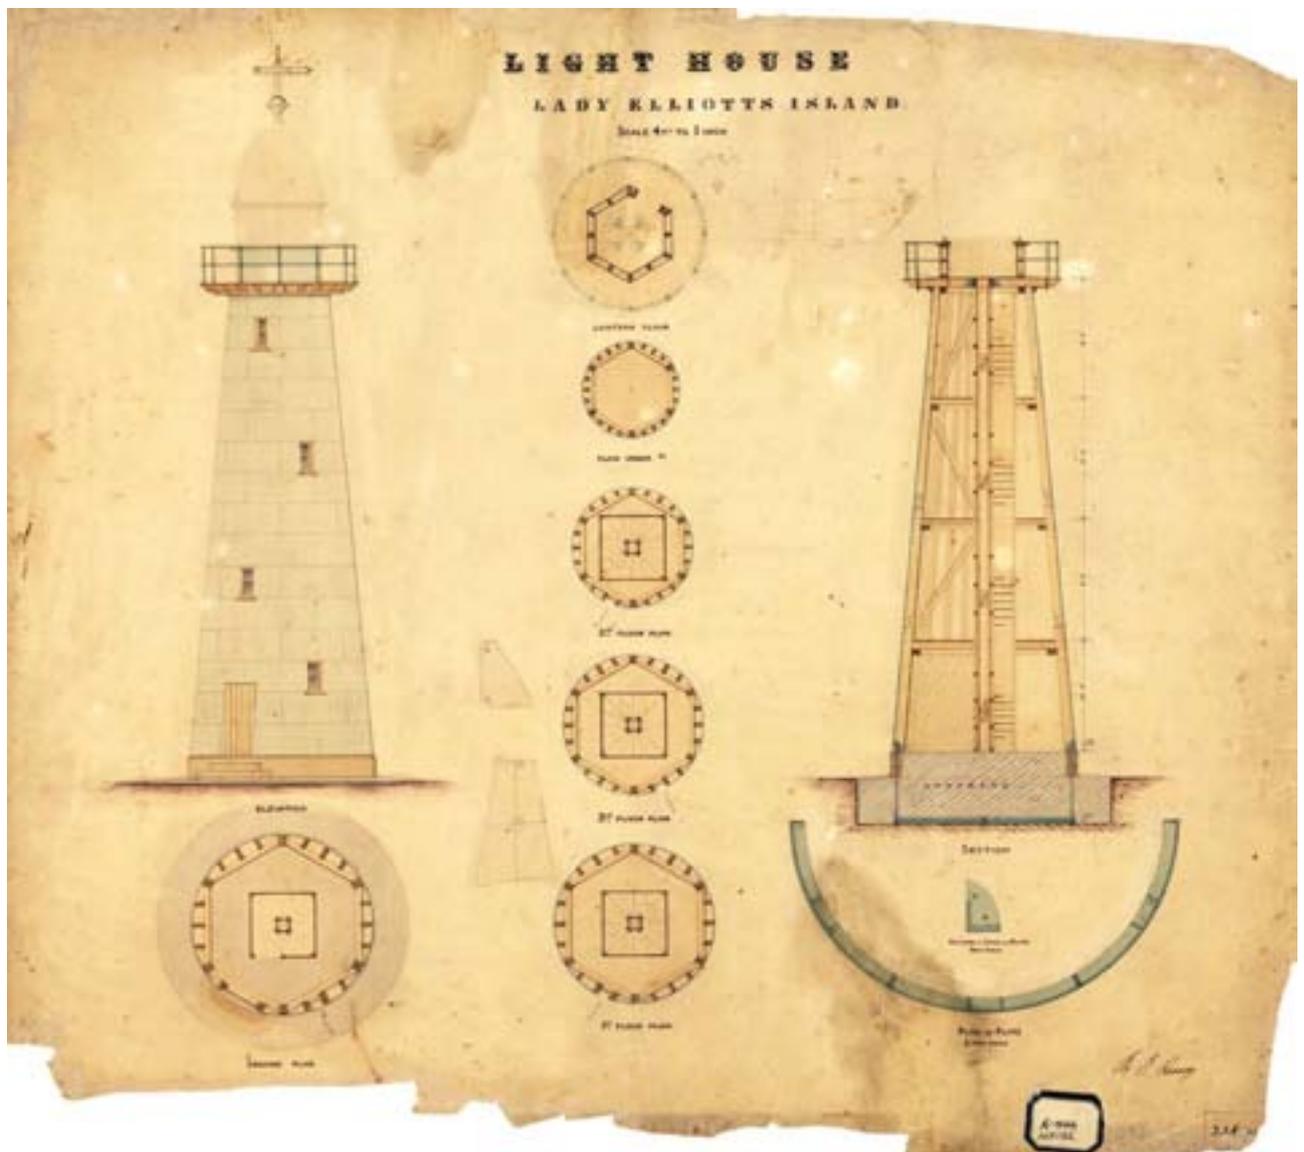
Figure 4. One of the contract drawings for the construction of the Lady Elliot Island lighthouse

The lighthouse tower was round in plan and tapered in profile, forming a truncated cone. The battered outer walls were framed with sawn hardwood posts and rails bolted together, with joints reinforced with wrought iron straps and brackets. The walls had light timber braces which would have served to stabilise the timber structure before the iron shell was fitted. There were three intermediate floors with hardwood joists and pine floor boards. In the centre of the tower was a vertical timber weight tube, which formed a central support for a winding timber stair that climbed up the bottom three levels of the tower. On the fourth level, where the conical tower was too small to fit a stair, there was a fixed ladder up to the level of the light room and balcony.

The frame was supported at the bottom by a segmented cast iron ring that formed a base, bolted down to a massive concrete footing and floor cast within a low stone wall. The timber posts were bolted to lugs made as part of the iron ring.

The tower was clad with a covering of galvanised wrought iron plates, about 2.5 mm thick, which were rolled to the conical shape. Joints between the plates were lapped and riveted, and the plating was screwed to the timber framework and to the iron ring at the base. A timber door was fitted at the bottom of the tower, and glazed windows at each floor level.

At the top of the tower was a timber framed structure which formed the floor of the lantern room and the projecting balcony surrounding the lantern. This balcony floor had a flooring of timber boards with a waterproof covering of lead sheet. On this floor was

assembled a hexagonal lantern room with a domed roof, all constructed by the building contractor – this was probably done to save the cost of an expensive imported prefabricated lantern. Inside the lantern was a typical Chance Brothers 4th order (250 mm focal radius) rotating optical apparatus with kerosene (paraffin) wick burner and weight-driven clockwork.

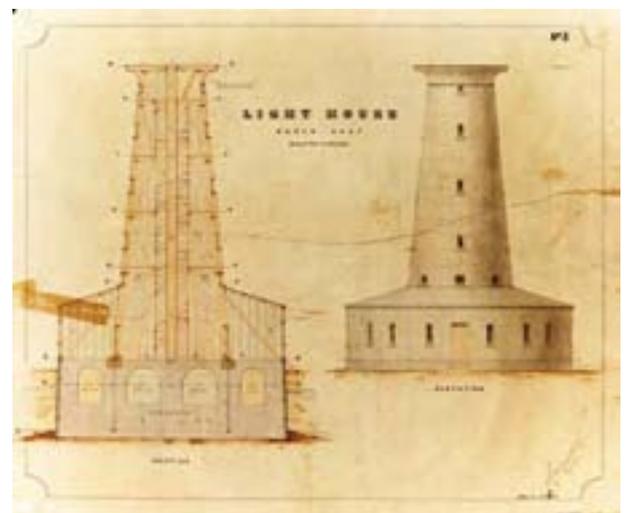
Figure 5. North Reef lighthouse, 1878

The tower sits on a cylindrical caisson of cast iron segments bolted together, sunk below low water onto a foundation of coral, and filled with concrete. This iron and concrete base is 13 m in diameter and 4.6 m high, with voids formed inside the mass of concrete for storage of fresh water. The tower was originally surrounded by the sand island, but the island later migrated away from the tower, leaving the lighthouse surrounded by water. It is now again surrounded by sand.

The 24 m high main tower was generally similar to that at Lady Elliot Island, but on a larger scale. There were four intermediate floor levels, and the optical apparatus was of the 2nd order. Apart from the iron and concrete base the most unusual aspect of the structure was the ring of rooms around the base of the tower. Here were the keepers' quarters, comprised of three bed rooms, two kitchens, two sitting rooms, and a store room – perhaps the head keeper had a private kitchen and sitting room, and the two assistant keepers had to share. The keepers quarters were framed and lined with timber, with a roof covering of galvanised iron with rolled seams, and external wall sheeting of corrugated galvanised iron.

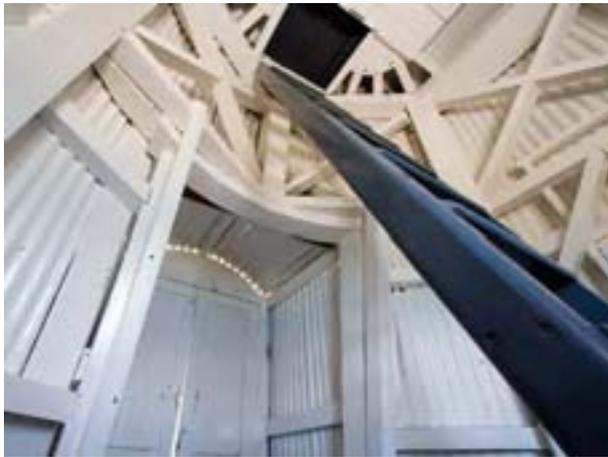
Figure 6. Interior of Goods Island lighthouse

at Goods Island in the Torres Strait. The timber framework had heavy timber cross bracing, but was otherwise similar to the iron plated type. The sheeting was specially formed with tapering corrugations to suit the conical shape of the tower.
